PROJECT: 11798

**ASBESTOS-CONTAINING  
BUILDING MATERIALS  
SURVEY REPORT**

**Williams Park  
1717 NW 5<sup>th</sup> Ave  
Miami, FL 33136**

May 25, 2006

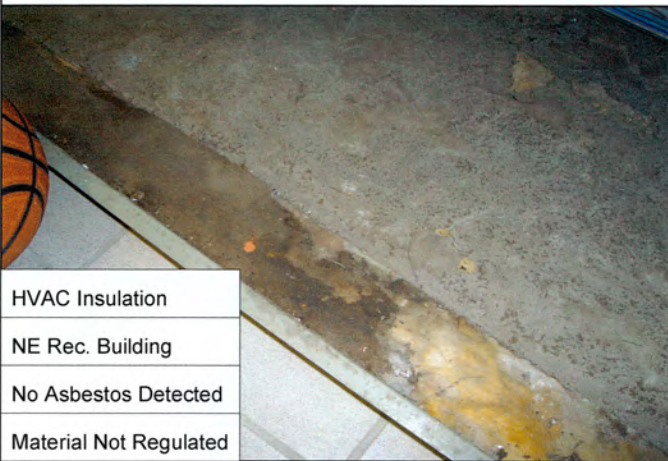
Sample JM051106-1-1

HVAC Insulation
NE Rec. Building
No Asbestos Detected
Material Not Regulated

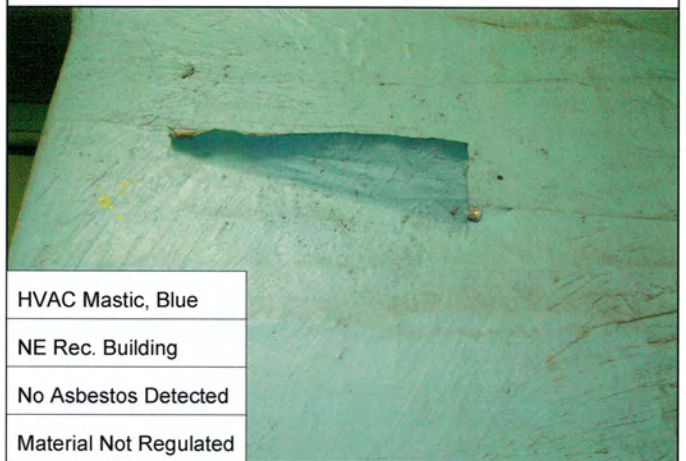
Sample JM051106-2-1

HVAC Mastic, Blue
NE Rec. Building
No Asbestos Detected
Material Not Regulated

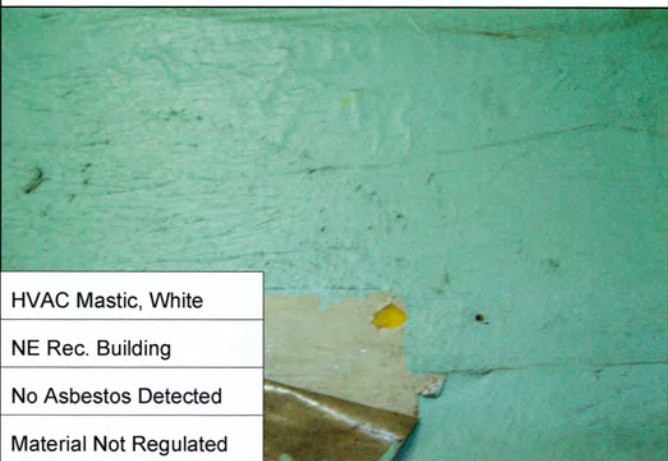
Sample JM051106-3-1

HVAC Mastic, White
NE Rec. Building
No Asbestos Detected
Material Not Regulated

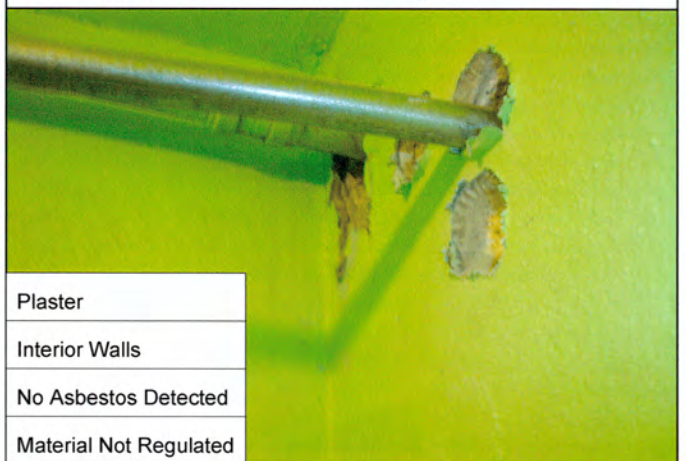
Samples JM051106-4-1 through JM051106-4-3

Plaster
Interior Walls
No Asbestos Detected
Material Not Regulated

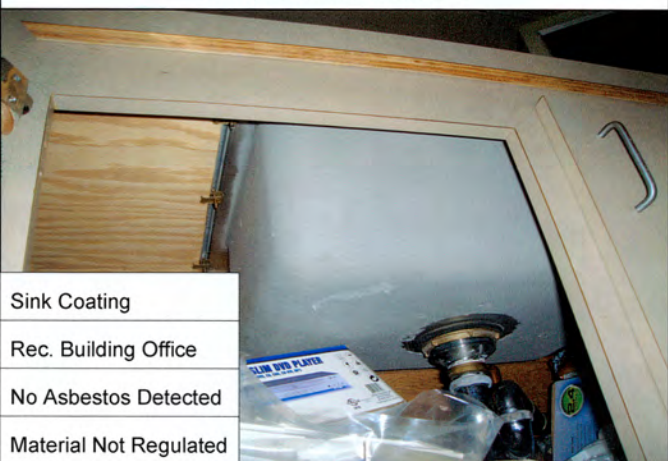
Sample JM051106-5-1

Sink Coating
Rec. Building Office
No Asbestos Detected
Material Not Regulated

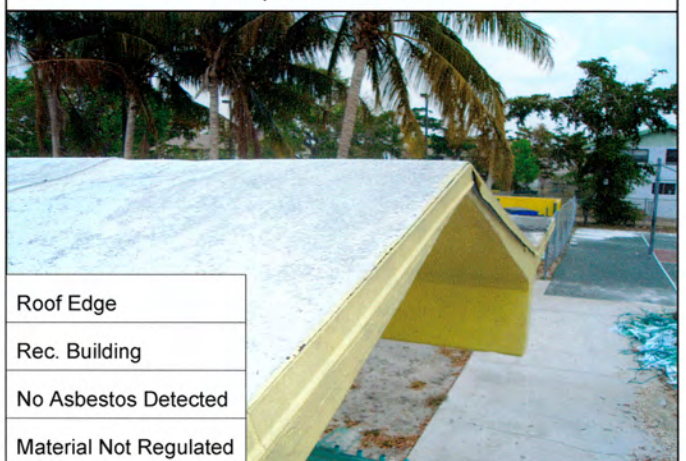
Sample JM051106-6-1

Roof Edge
Rec. Building
No Asbestos Detected
Material Not Regulated

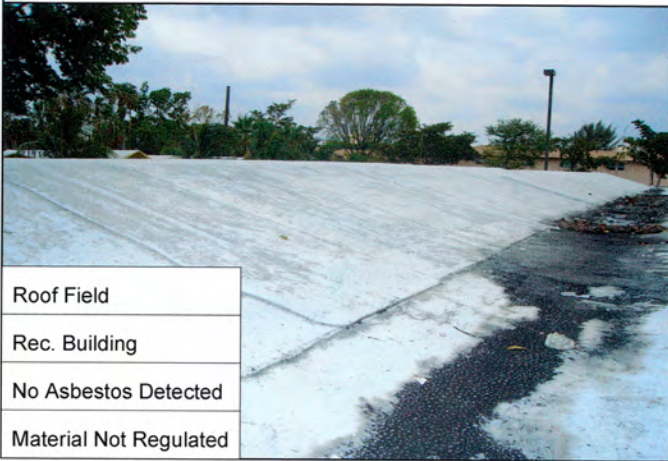
Sample JM051106-7-1

Roof Field
Rec. Building
No Asbestos Detected
Material Not Regulated

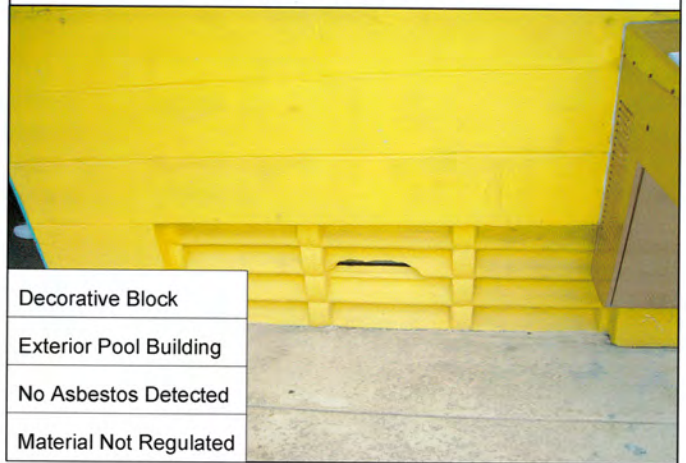
Sample JM051106-8-1

Decorative Block
Exterior Pool Building
No Asbestos Detected
Material Not Regulated

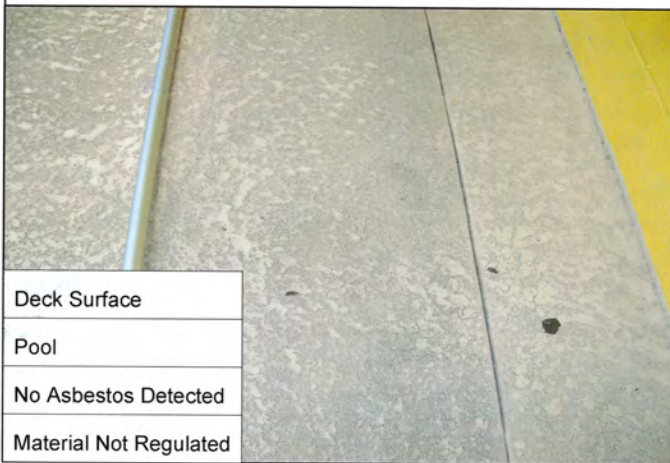
Sample JM051106-9-1

Deck Surface
Pool
No Asbestos Detected
Material Not Regulated

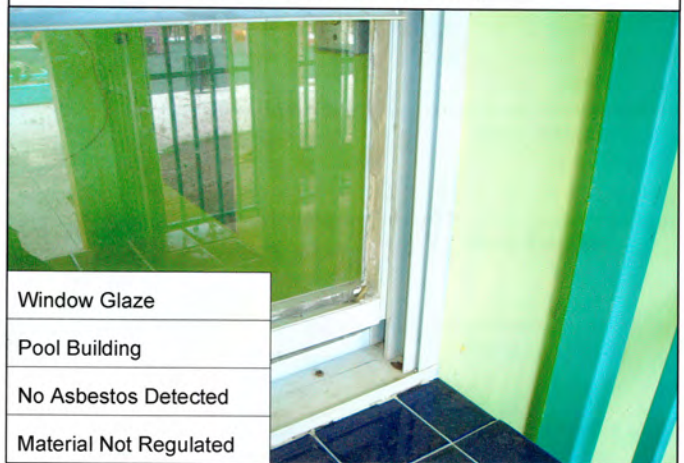
Sample JM051106-10-1

Window Glaze
Pool Building
No Asbestos Detected
Material Not Regulated

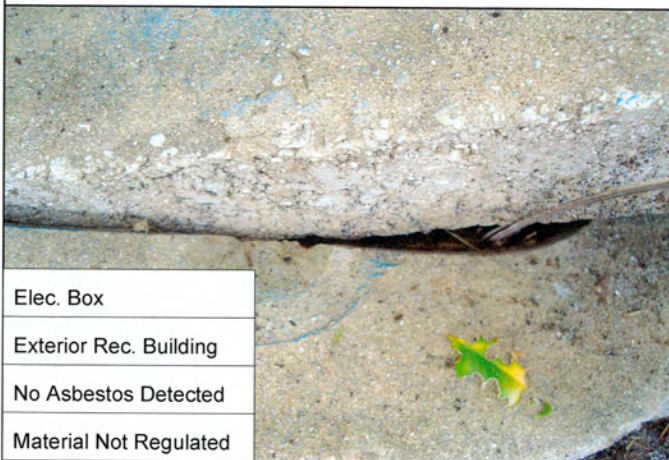
Sample JM051506-11-1

Elec. Box
Exterior Rec. Building
No Asbestos Detected
Material Not Regulated
